NO. WAL 710/774

Investigation of Salvaged M1 Helmets

DATE 23 August 1945

WATERTOWN ARSENAL LABORATORY
MEMORANDUM REPORT No. WAL 710/774
Final Report on Problem E-7.23

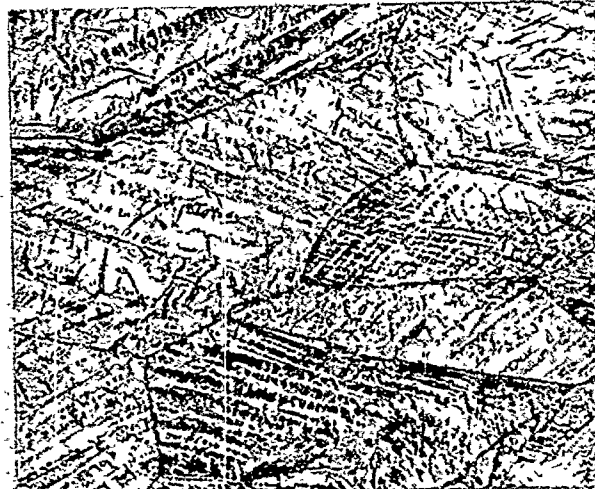
Metallographic examination of the burnt areas of several of the helmets indicated that some of them had been heated to well over 600°F. Above approximately 600°F., austenitic manganese steel is unstable with respect to precipitation of carbides along slip planes and grain boundaries. Carbide precipitation results in severe embrittlement of the steel. Excellent data

Figure 1B shows the microstructure of the burnt zone of helmet SB7. Very extensive carbide precipitation is evident. The microstructure of the portion of the helmet which was unaffected by the heat consists of the normal cold-worked austenitic structure free of carbides.

Nital Etch. -B- Mag. X1000
 Microstructure of burnt zone of above helmet.
 Carbides precipitated at grain boundaries
 and along slip lines.

In view of the possibility that any burnt helmet may have been heated to a sufficiently high temperature (above approximately 600°F.) to cause carbide precipitation and consequent embrittlement, it is deemed inadvisable to attempt the salvage of any burnt helmet. Helmets should never be allowed to undergo combat service.
